SAFETY ANALYSIS REPORT

About the project: This report is part of a two-year project implemented by The Asia Foundation in partnership with SafetiPin and the Centre for Social Research (CSR), on "Making Cities Safe for Women in India." The project goal is to engage diverse stakeholders tasked with improving public place safety for women in three Indian cities: Bhopal, Gwalior (Madhya Pradesh), and Jodhpur (Rajasthan). Supported by the Korea International Cooperation Agency (KOICA), the project initiates an evidence backed dialogue with policy makers, police, and civil society organizations about the challenges women face in accessing and enjoying public places and proposes implementable solutions to address these challenges.

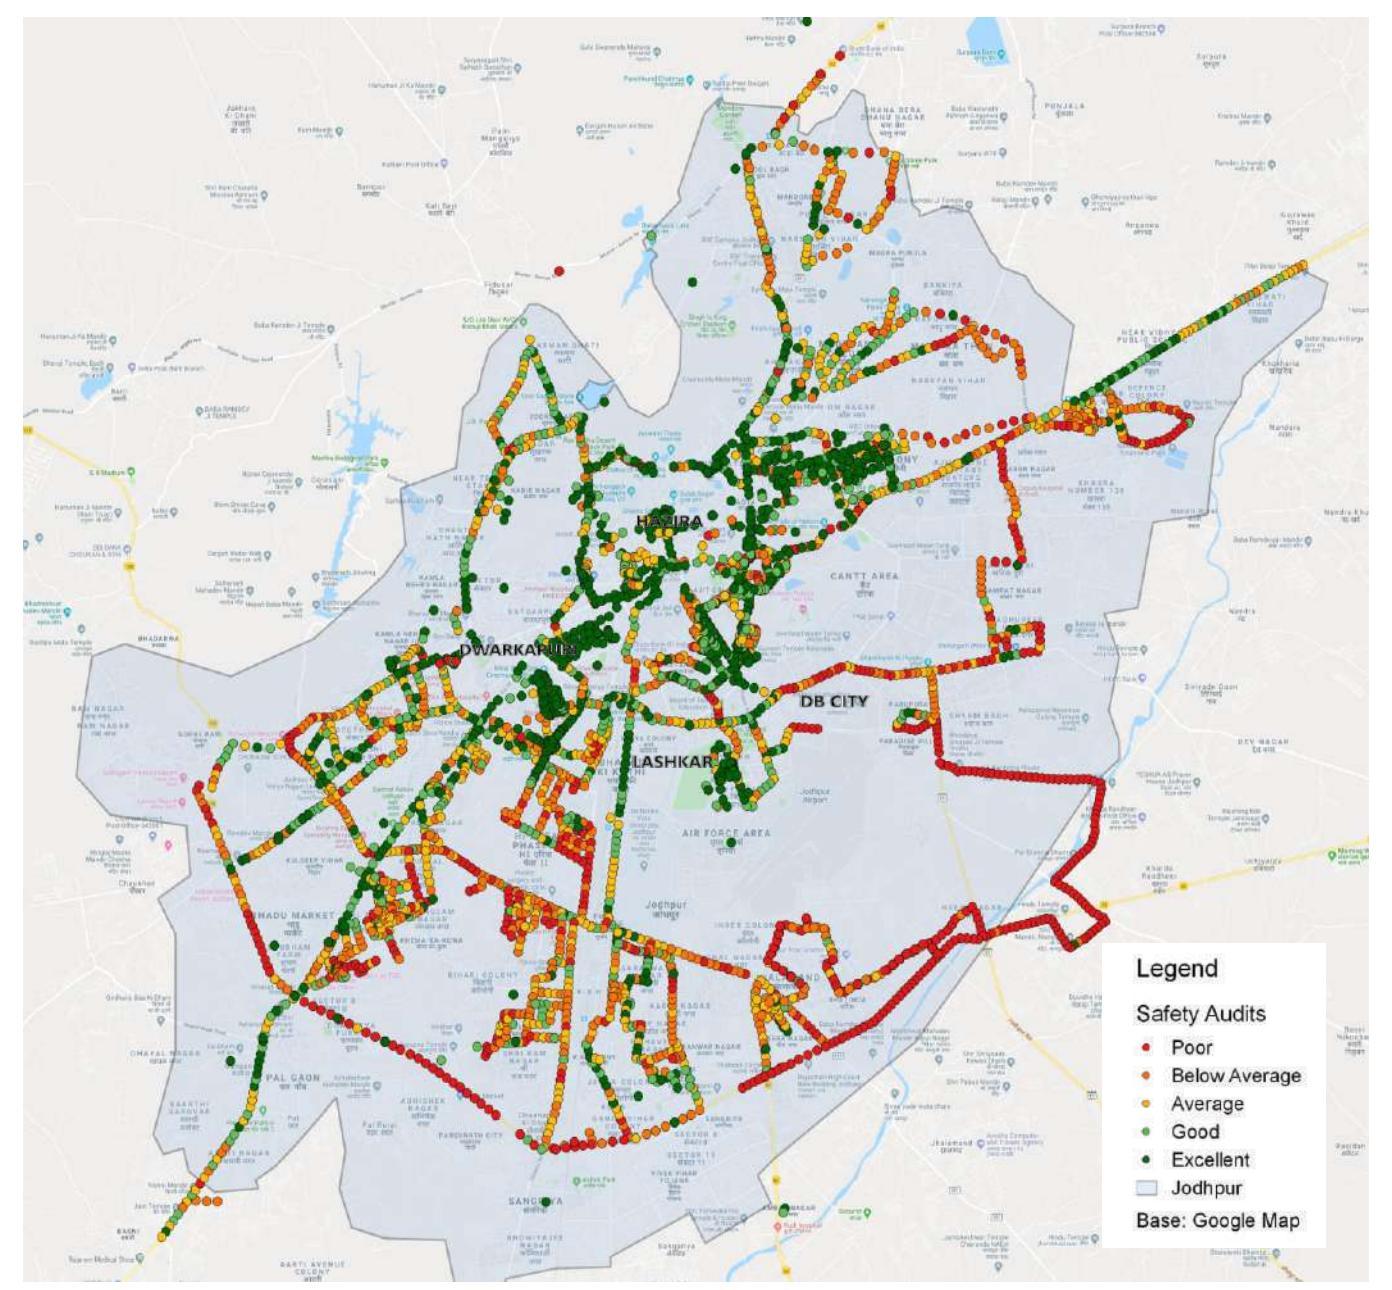
Map 1. Indicating Safety Score ratings

Indicated in the pie chart is the percentage distribution of pins in each range. 16% of the audit points were rated poorly i.e. safety score equal to or less than 1/5. As seen in the Safety Score map below, many of these points are located on the outskirts of the city. 37% of the points have been rated as Good in terms of overall safety in Jodhpur.

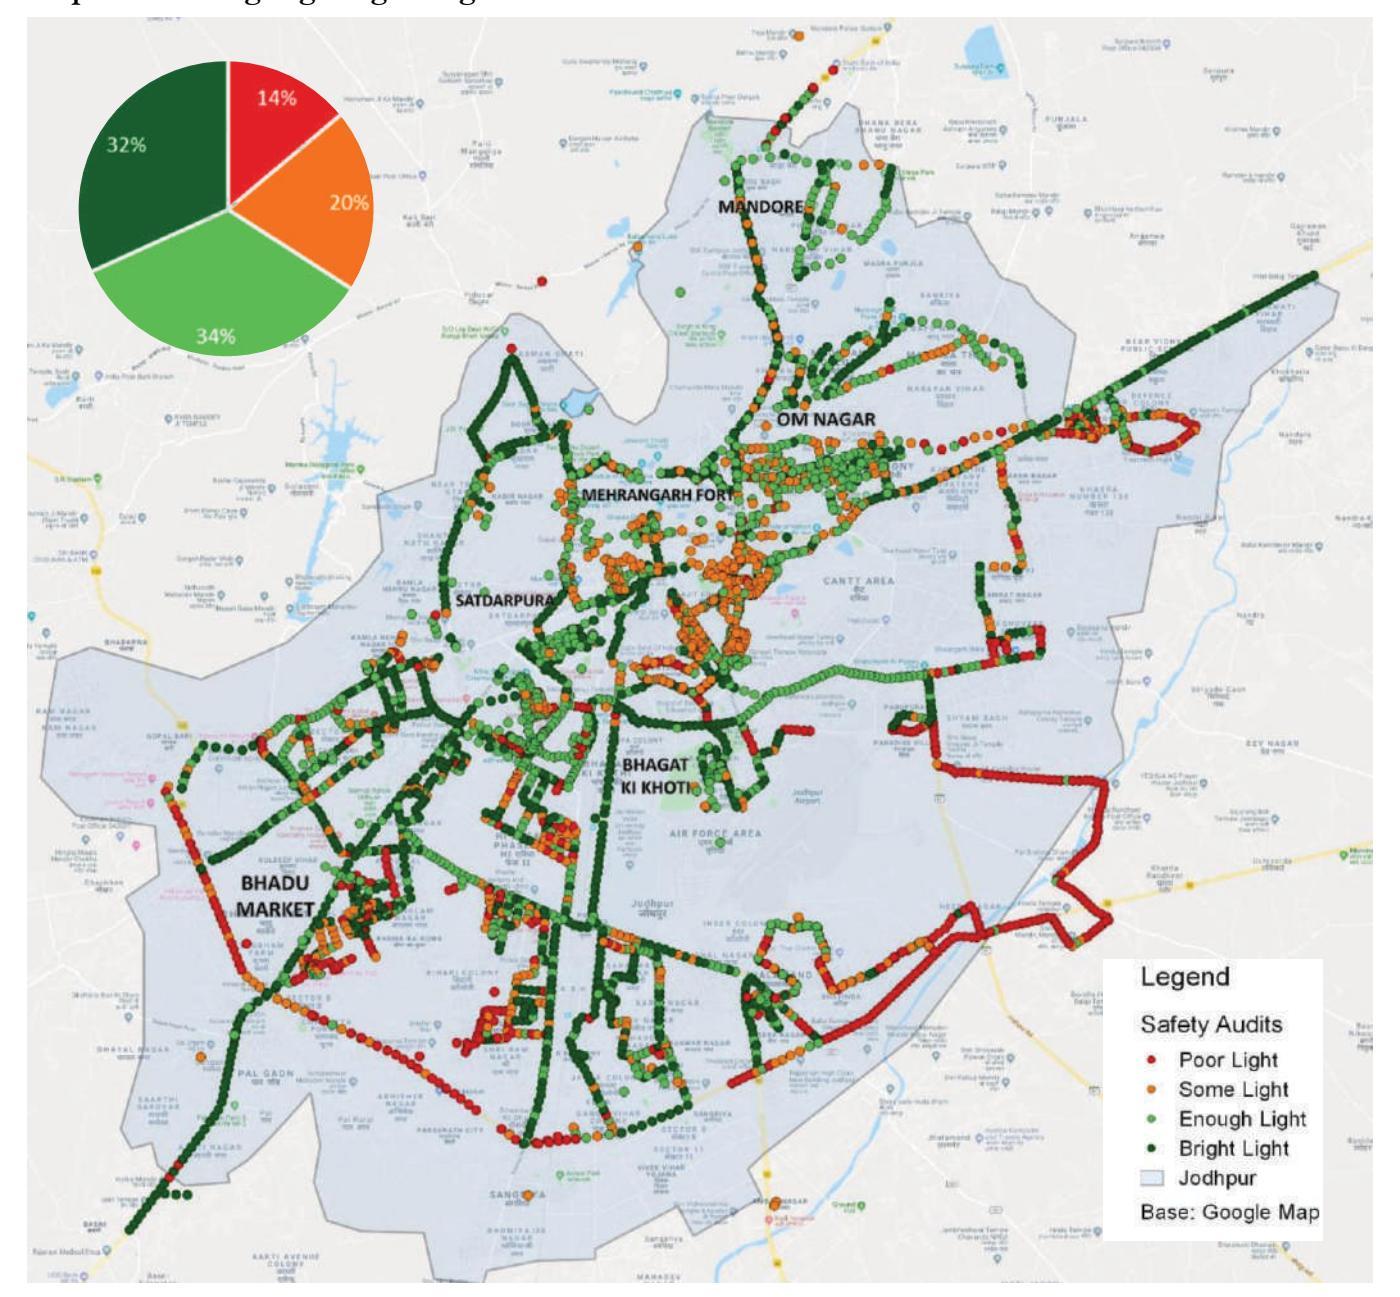
Map 2 Indicating Lighting rating

Lighting has been rated 1.8/3 i.e. Average. 14% of the audit points (as shown in map 3) have been rated poor and identified as dark spots in the city indicating no source of lighting and no streetlights installed along the road. Streetlights need to be installed along these points to remove the dark spots.

The existing streetlights that have been found non-operational need to be checked. Regular checks should be carried out to ensure uniform and unobstructed illumination. Streetlights need to be installed along areas, identified as dark spots i.e. at these locations there is no illumination at present.

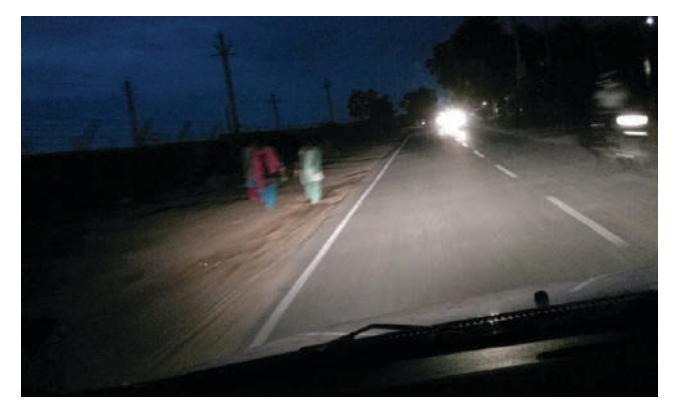
Image showing a stretch with no streetlights

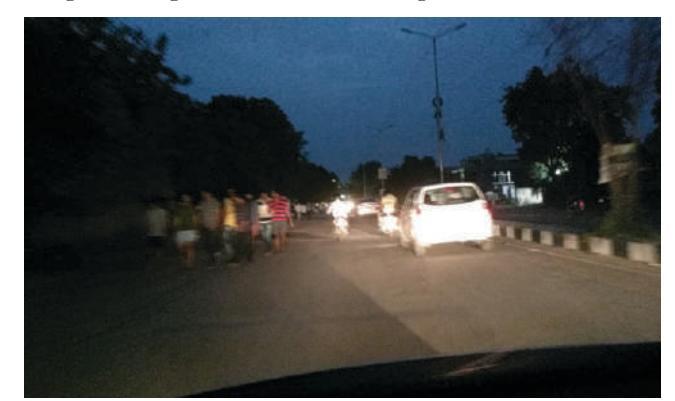
Image showing non-functional streetlights

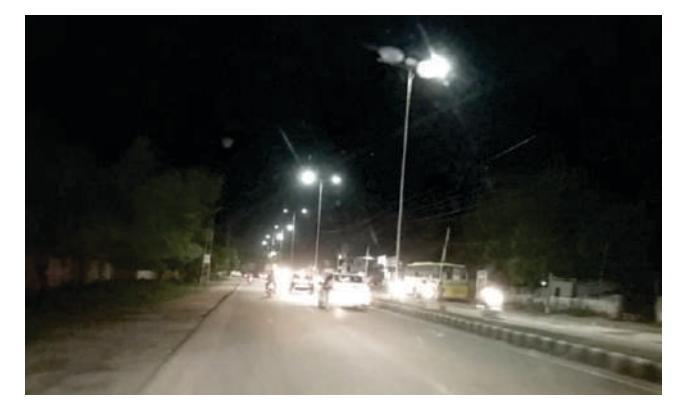
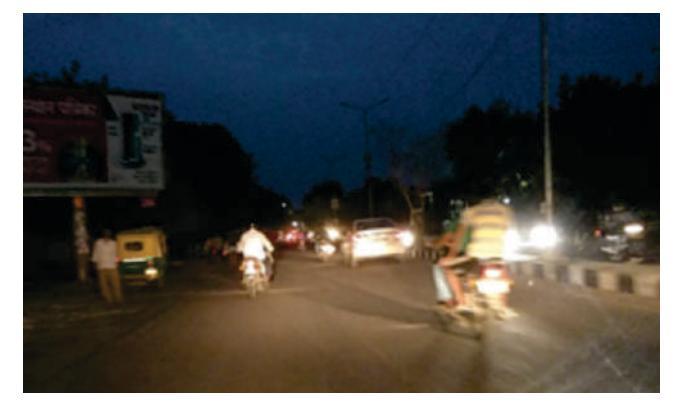
Image showing streetlights on only one side of the main road

Along the main roads having four lanes or more, streetlights are provided along the central median of the road. In such cases, additional streetlights need to be installed along the footpath. Pedestrian scale streetlights should be installed such that the footpaths are also well light.

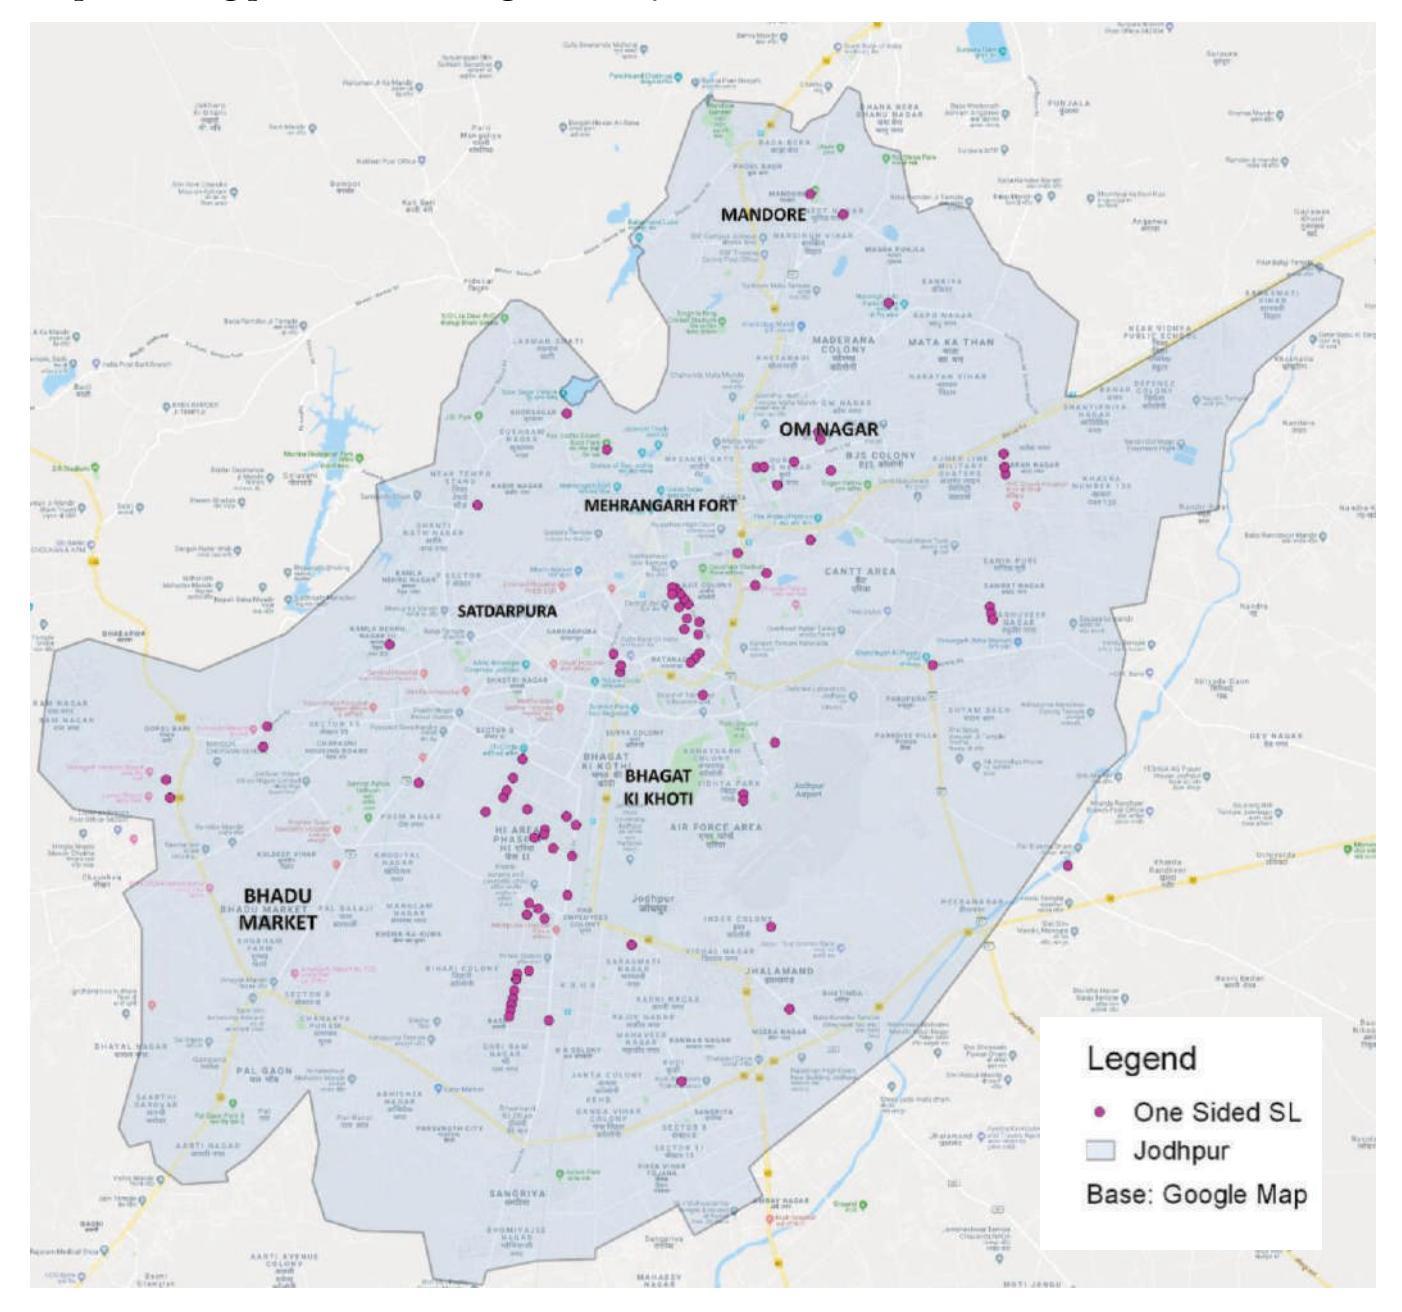
Map 4 Showing points with streetlights on only one side of main roads

20% of the audit points (as shown in map 3) were rated Below Average as streetlights were found to be non functional at the time of audits. On roads with more than 4 lanes, streetlights that are installed along the central median results in a well-lit vehicular carriageway but a poorly lit walkpath. These audit points have been shown in map 4. Only 32% of the audit points were rated as Good in terms of lighting.

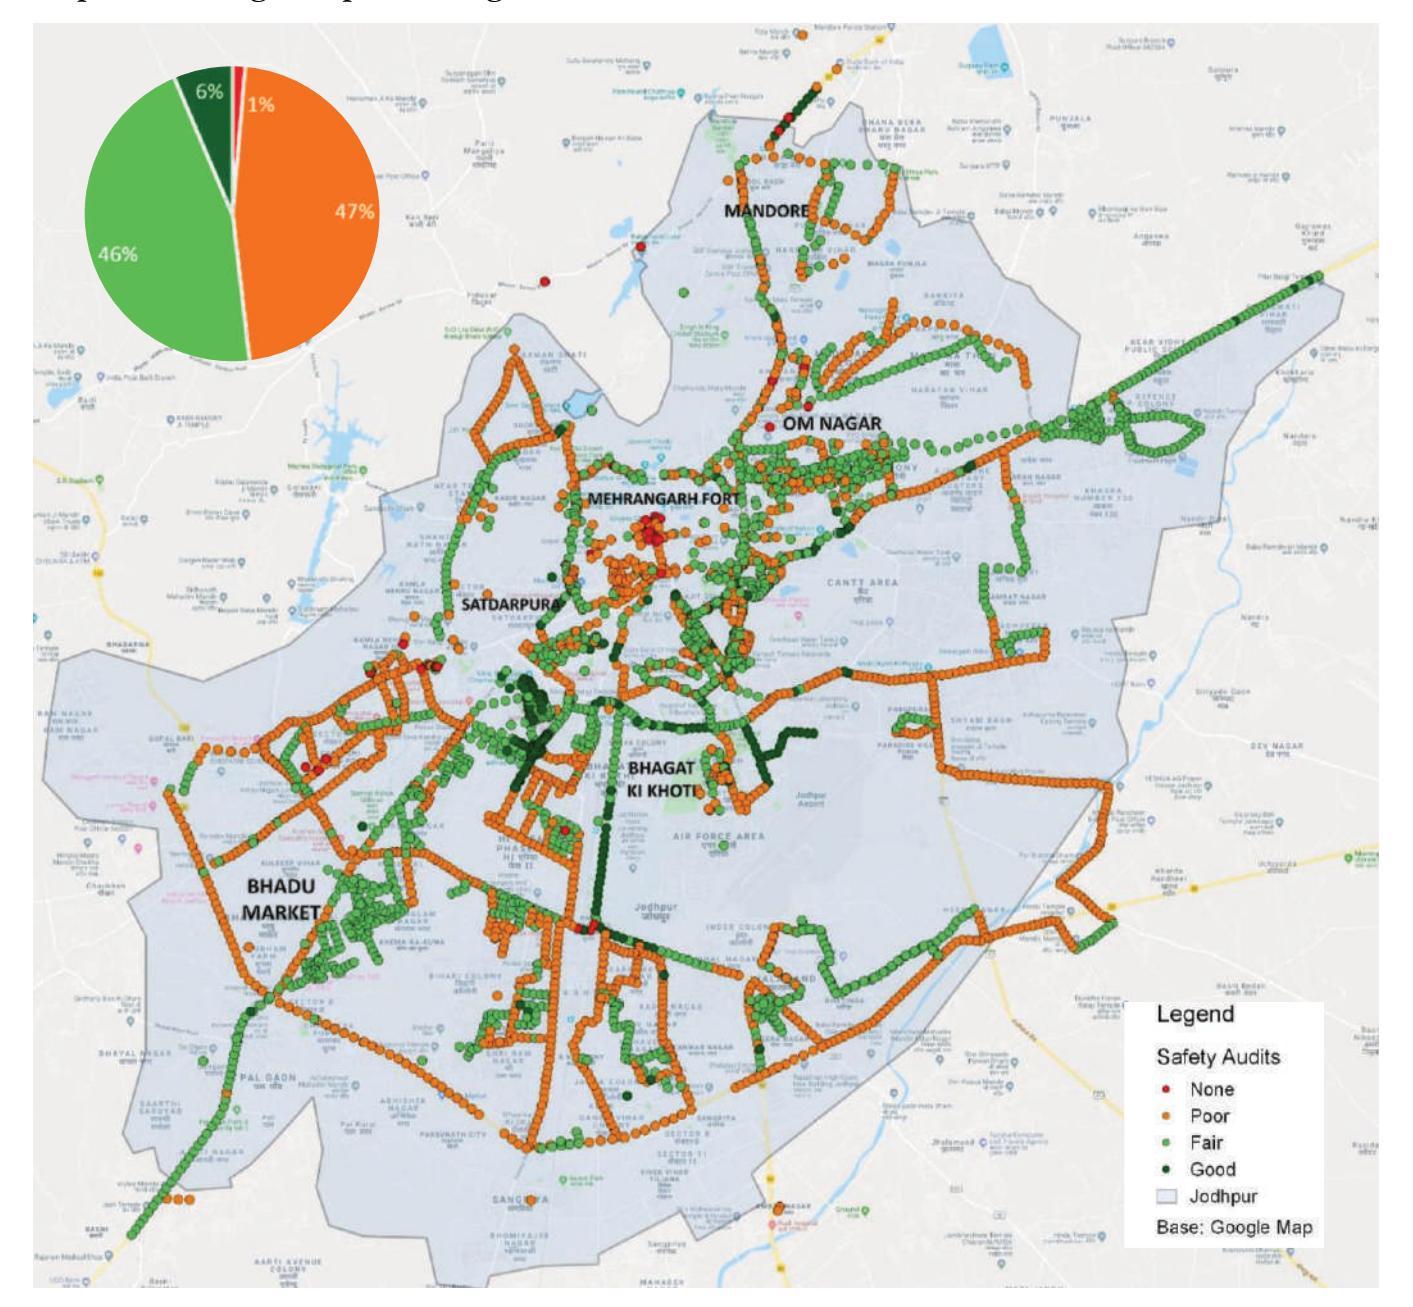
Map 5 Indicating Walkpath Rating

Walkpath parameter indicates whether a person can comfortably walk at a place. This refers to the quality of walkpath or space left for pedestrians along a road. Walkpath has been rated 1.6/3 i.e. Average. 52% of the audit points have been rated 2 and above for Walkpath parameter indicating presence of footpath at these points. However, the footpath is not accessible at most of the places. This is primarily attributed to the obstructions on the footpath. The obstructions include vehicular parking, dumping of construction debris, inappropriate positioning of signage and street furniture on the footpath. Obstructions on the footpath like vehicular parking should be installed along the edge of the footpath, clear of the pedestrian path to ensure seamless and accessible walkpath for the pedestrians.

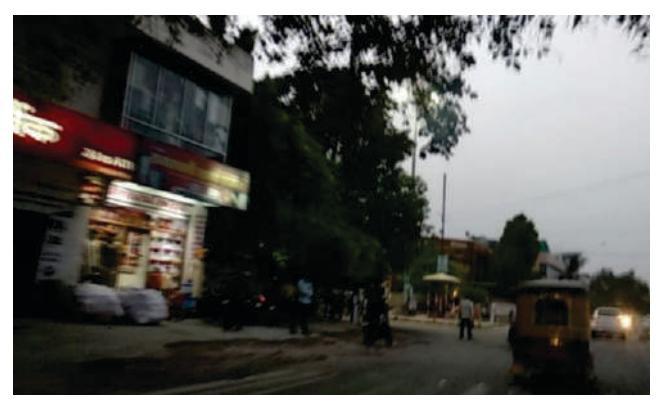
Image showing a stretch with broken footpath

Properly paved footpath should be constructed at points with unpaved or broken walkpath and they should be maintained regularly.

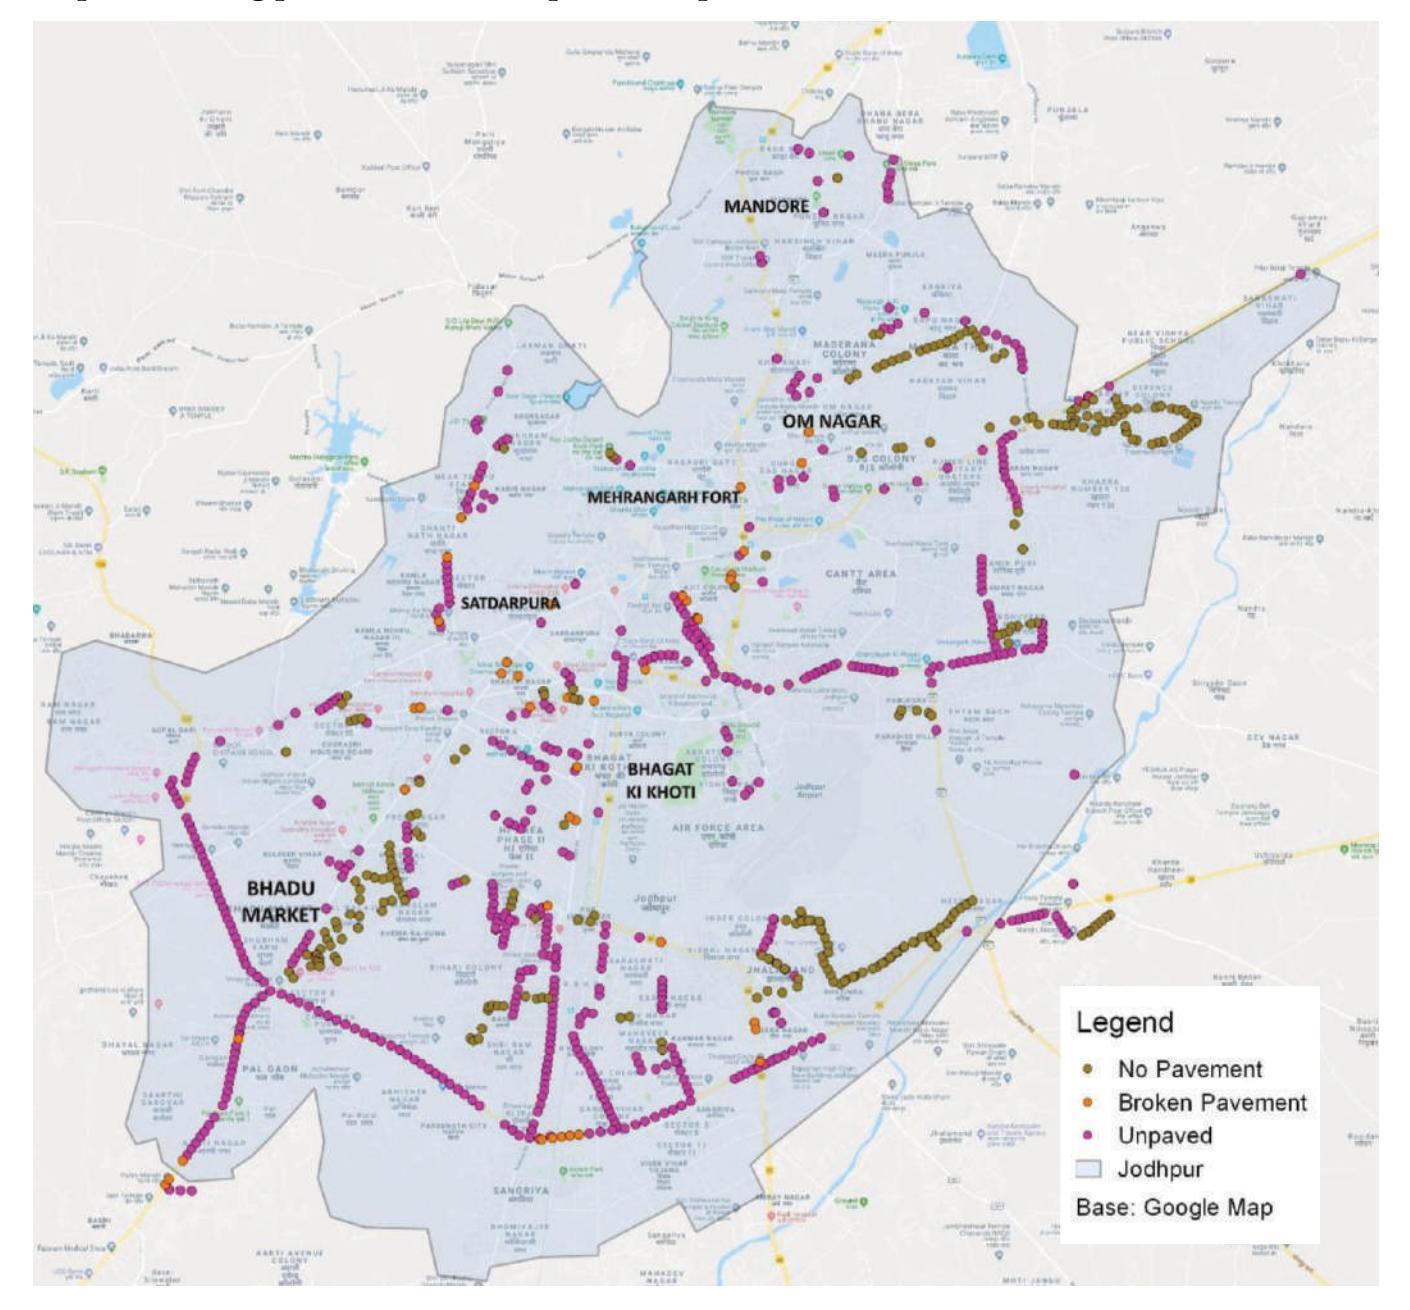
Map 6 Indicating points with no or unpaved walkpath.

48% of the audit points were rated poor in Jodhpur. Map 6 shows audit points where walkpath is either unavailable, unpaved/kacha or broken. At these points, proper footpath needs to be constructed and maintained regularly. Map 7 shows audit points with obstructions on the walkpath.

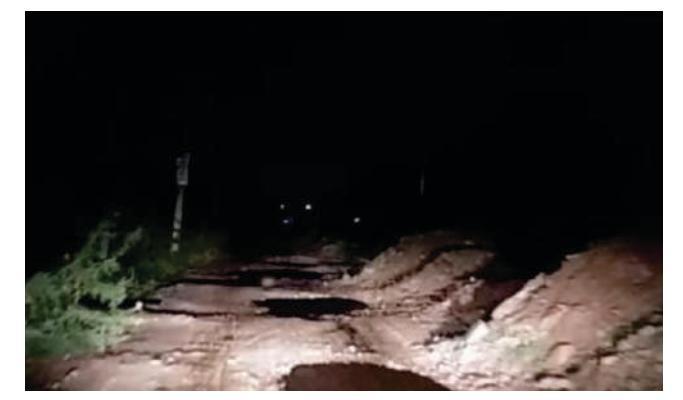
Image showing walkpath being obstructed by vehicular parking

Image showing walkpath being obstructed by Construction debris

Footpath should be kept free from any obstructions. Obstructions due to vehicular parking, construction debris or extended shops should be removed. Designated space to be provided for onstreet parking clear of pedestrian path. Space should also be provided for hawkers as they help in making streets active hence safer for women pedestrians.

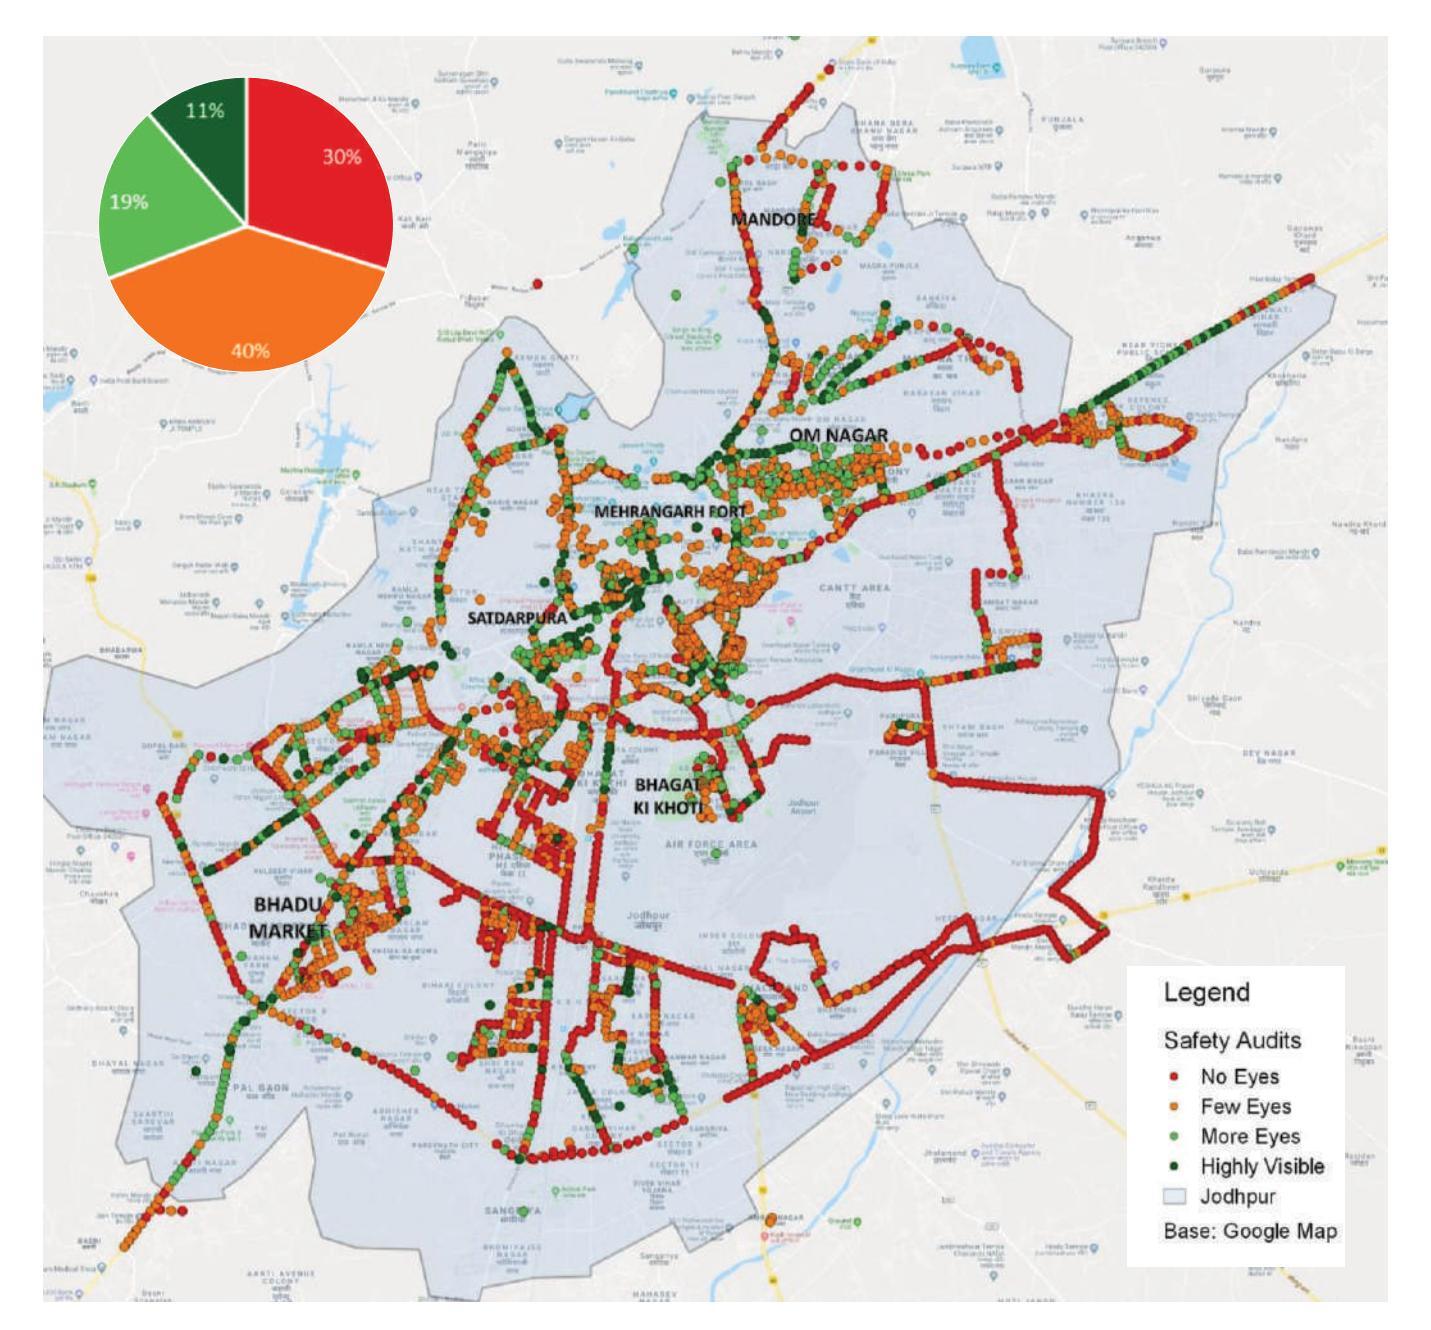
Map 8 Indicating Visibility Rating

Visibility refers to how visible is one to others. It is based on the principle of 'eyes on the street'. i.e. can you be seen when on the street. This includes windows- doors of shops, houses along with street vendors and hawkers. Visibility has been rated 1.1/3 i.e. Below Average in Jodhpur. About 70 % of the audits have been rated Poor or Below Average. One of the reasons for low visibility is presence of high boundary walls in many areas. Jodhpur is famous for its historical places like forts and palaces in the city which have high solid boundary walls. Additionally, parcels of unused or vacant land exists in the peripheral areas of Jodhpur where urbanization is low thus resulting in low visibility.

To improve visibility, the design of the boundary walls should be altered wherever possible. The height of the solid part of the boundary wall should be reduced to 1-2 m and the rest of the height can be attained through grills. This would maintain some level of transparency between the streets and the buildings thus making pedestrians feel safer. Additionally, designated spaces i.e. 'hawker zones' should be provided at places where vendors are present to maintain natural surveillance.

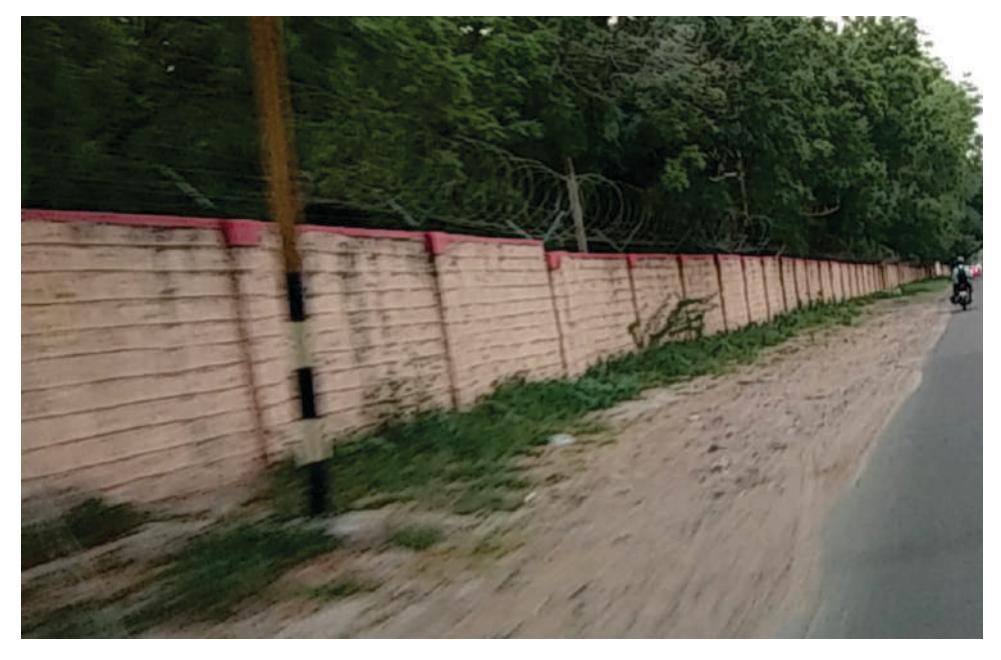
Image showing a stretch with high boundary wall

High boundary walls result in poor visibility along the walkpath. Wherever possible, the height of the solid part of the boundary wall should be maintained at 1m. Above the solid part, grills can be used to achieve the remaining height. Inactive edges along the footpath instill a sense of fear in the pedestrians.

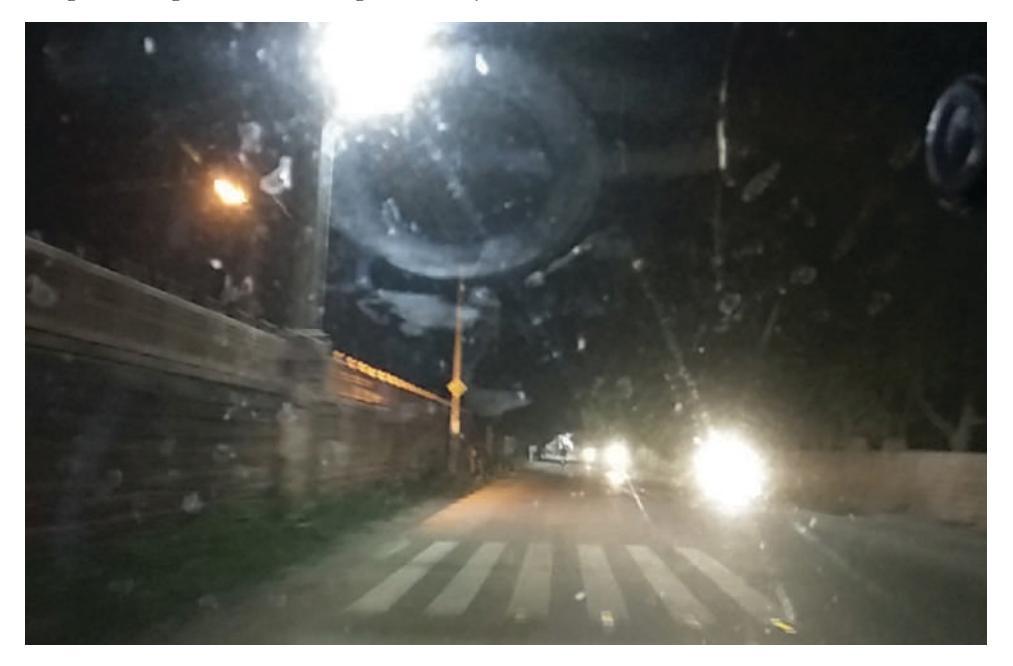
Image showing a stretch with high boundary wall

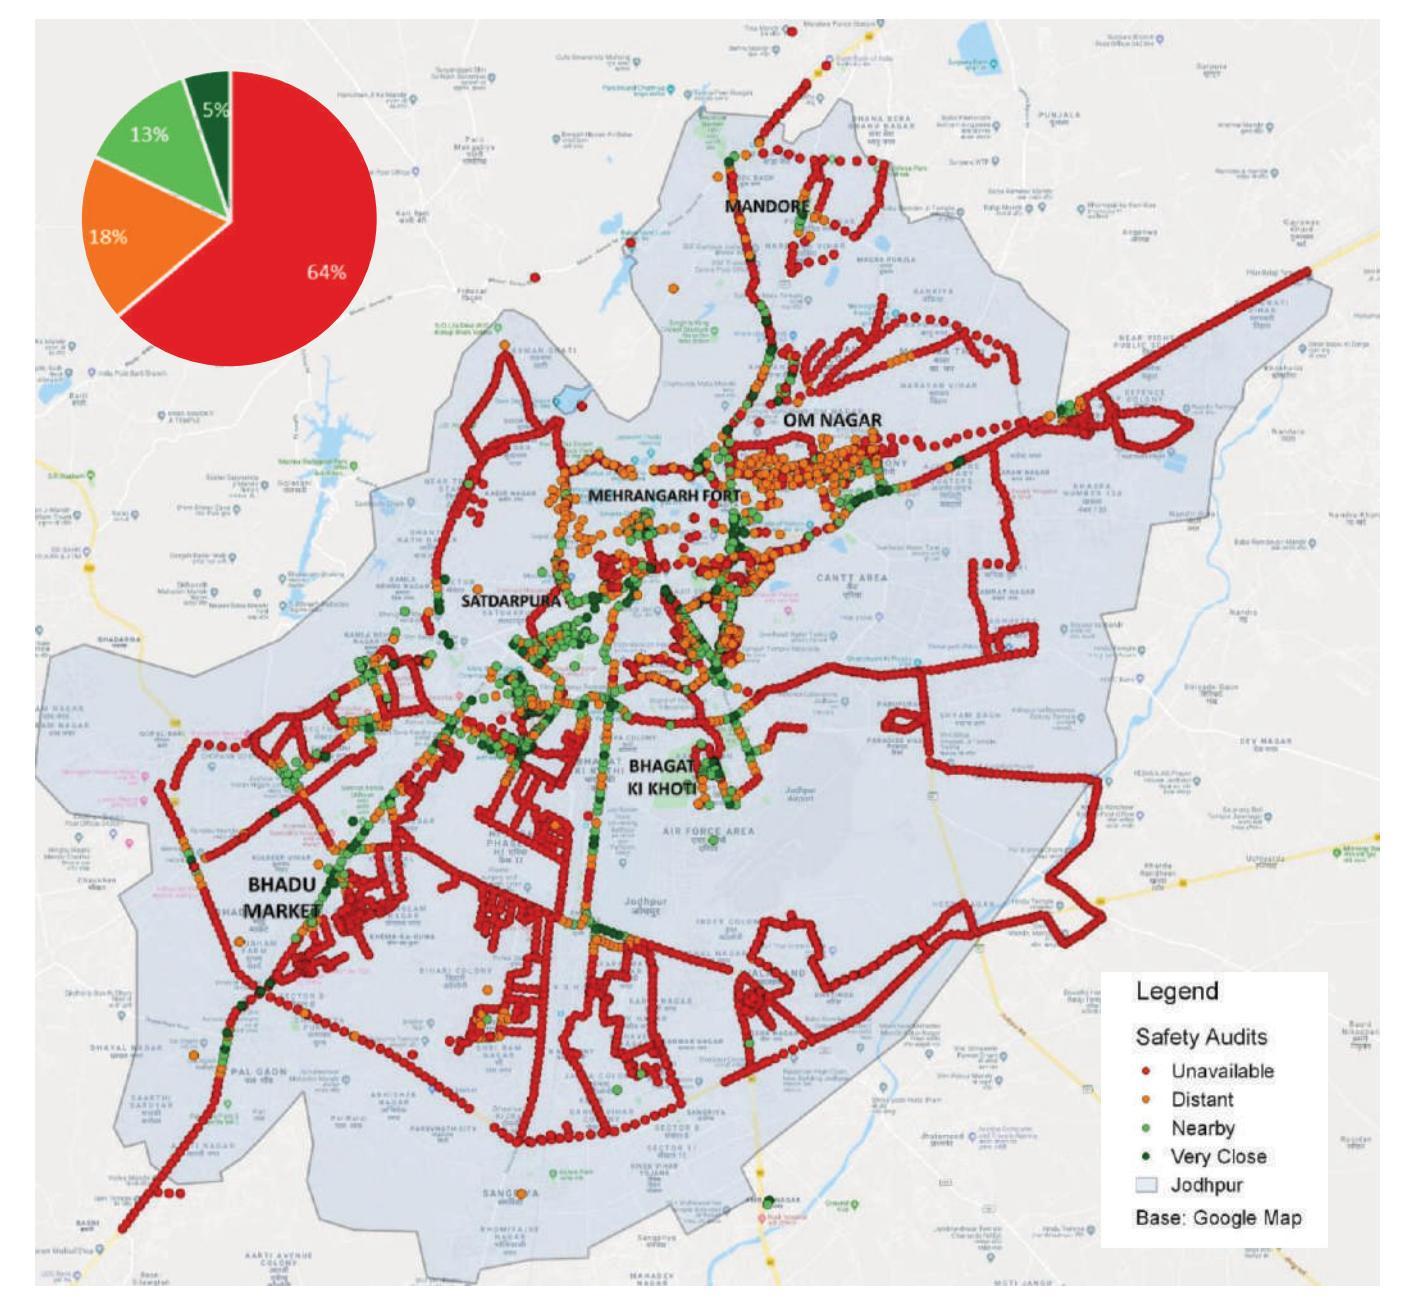
Map 10 Indicating Public Transport Rating

Public Transport has been rated 0.6/3 i.e. Poor. At present, mainly private buses are plying in the city and very few government buses are operational. 64% of the audit points have no bus stop within 10 mins walking distance. Map11 shows the audit points where People parameter has been rated high but are more than 10mins walking distance from the nearest bus stop. Many residents opt for autos or tata magic, with auto being the major form of intermediate public transport in Jodhpur.

In addition to improving and extending the existing bus network, bus shelters needs to upgraded. Designated well lit auto stands should be set up with proper space for parking autos at major market places and landmarks around the city. Additionally, street furniture and convenience facilities for the commuters and drivers should also be located nearby.

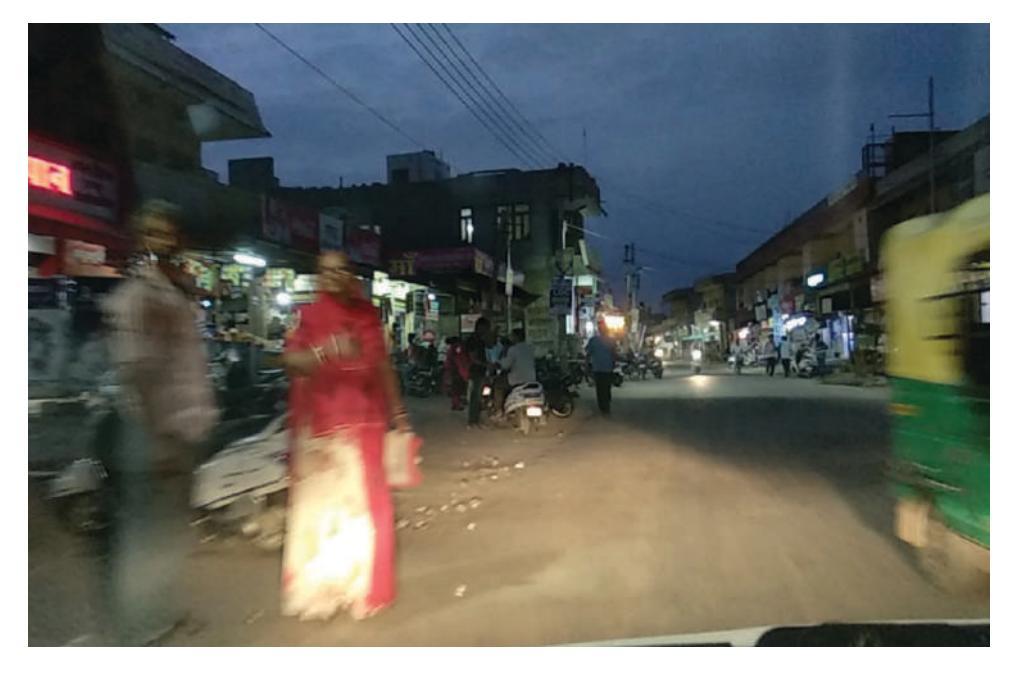
Image showing a stretch with parameter Public Transport (rating 0) and People (rating 2)

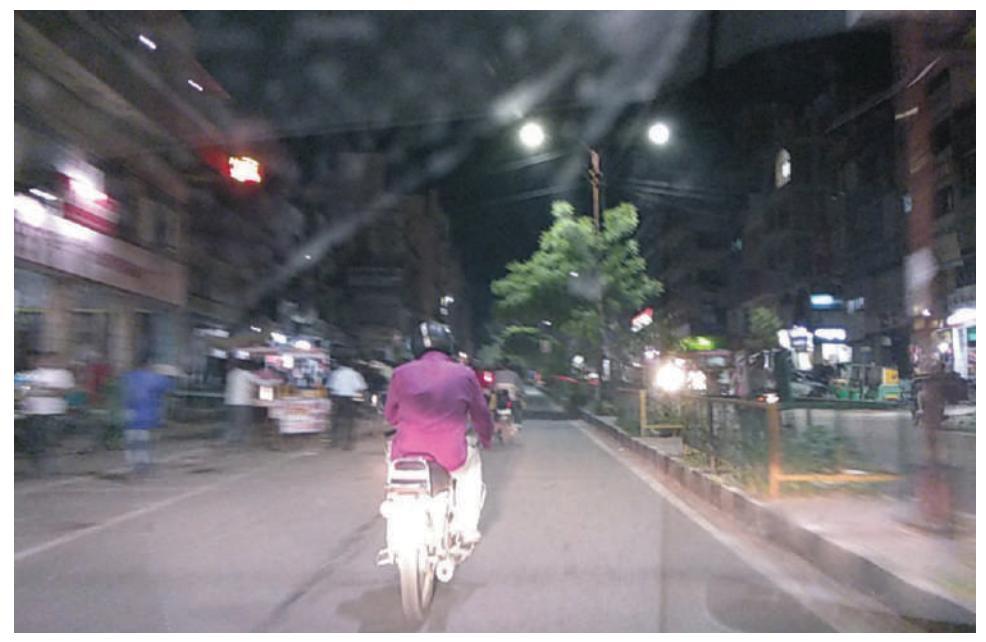
Image showing a stretch with parameter Public Transport (rating 0) and People (rating 3)
