SAFETY ANALYSIS REPORT

About the project: This report is part of a two-year project implemented by The Asia Foundation in partnership with SafetiPin and the Centre for Social Research (CSR), on "Making Cities Safe for Women in India." The project goal is to engage diverse stakeholders tasked with improving public place safety for women in three Indian cities: Bhopal, Gwalior (Madhya Pradesh), and Jodhpur (Rajasthan). Supported by the Korea International Cooperation Agency (KOICA), the project initiates an evidence backed dialogue with policy makers, police, and civil society organizations about the challenges women face in accessing and enjoying public places and proposes implementable solutions to address these challenges.

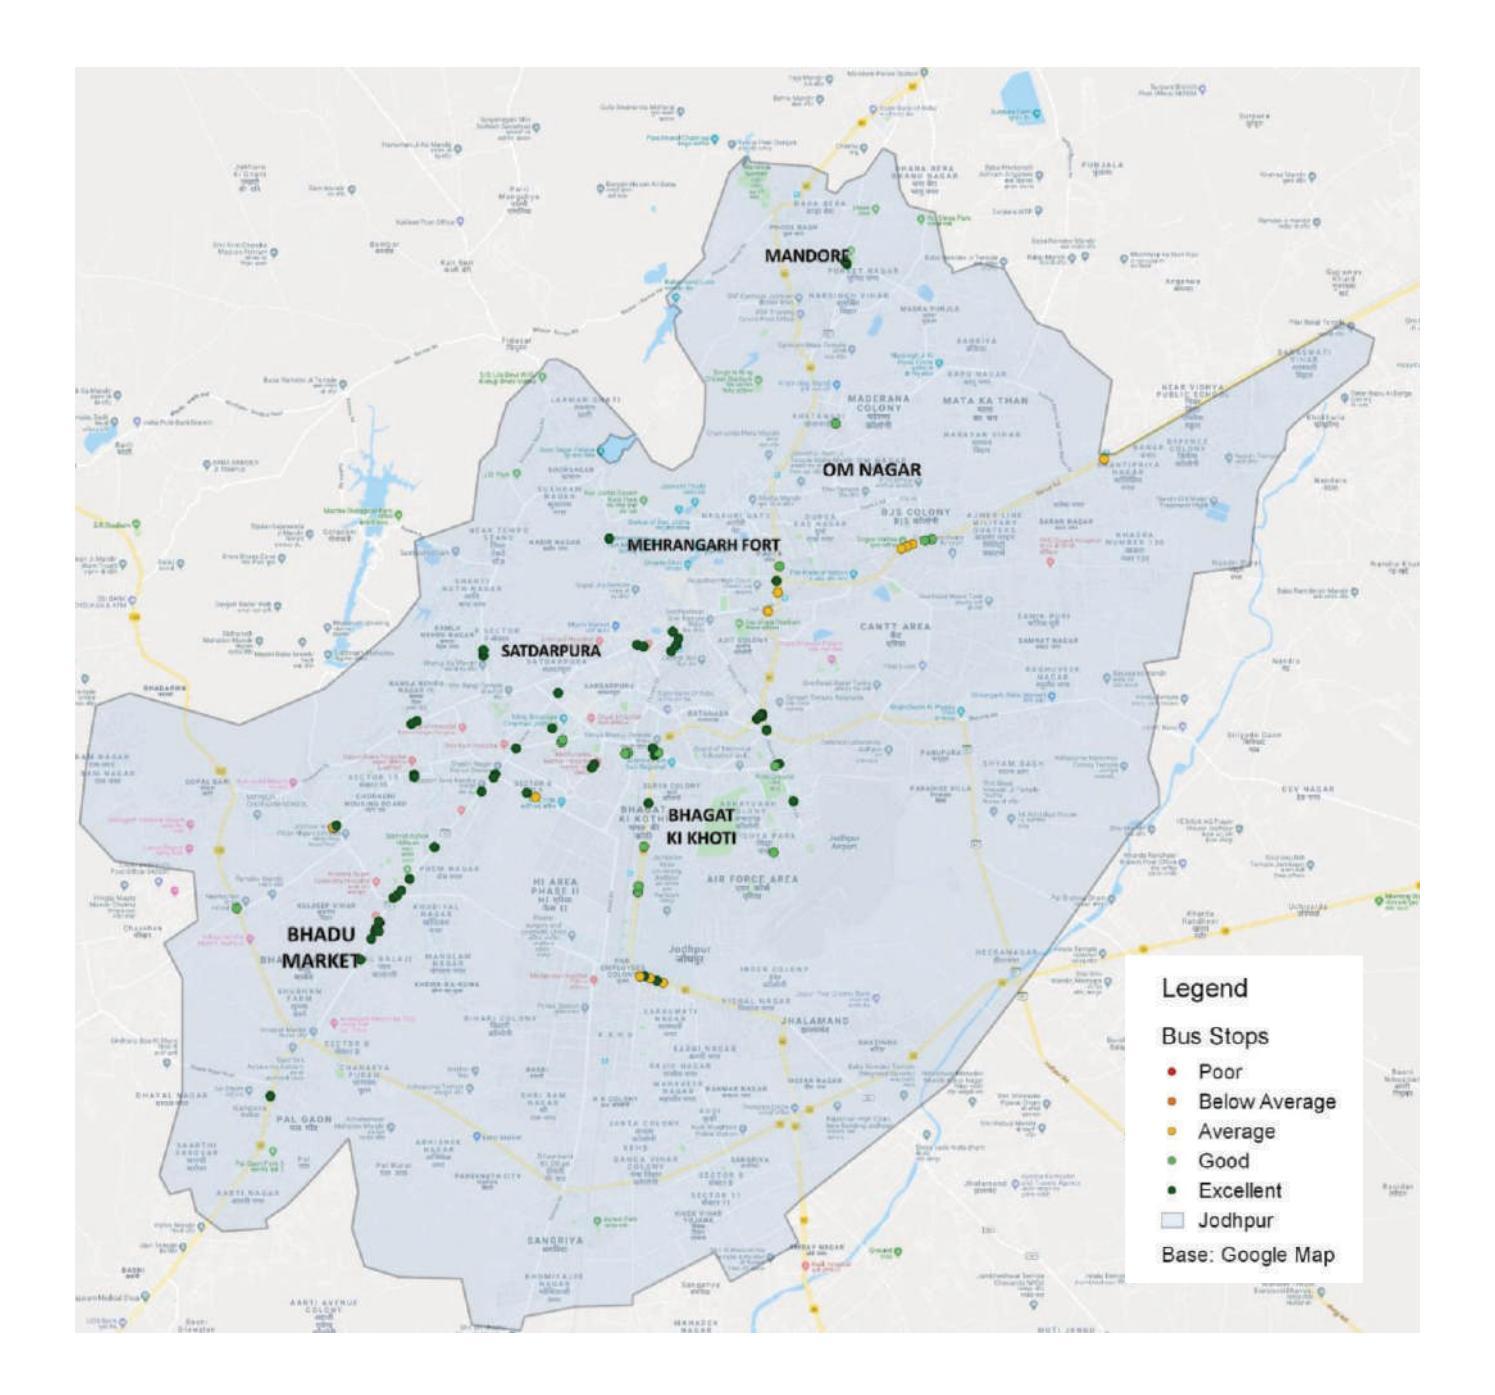
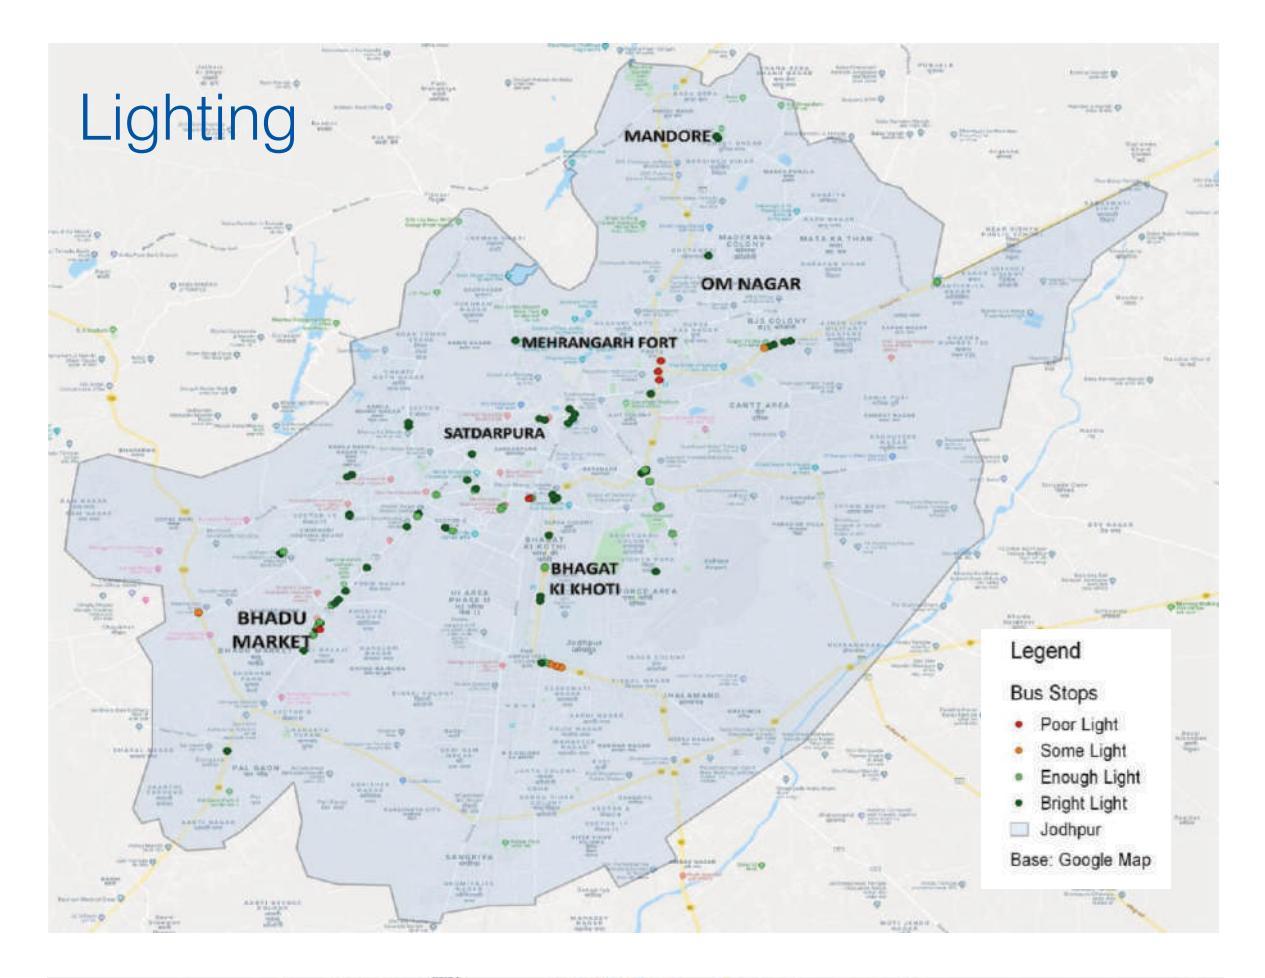
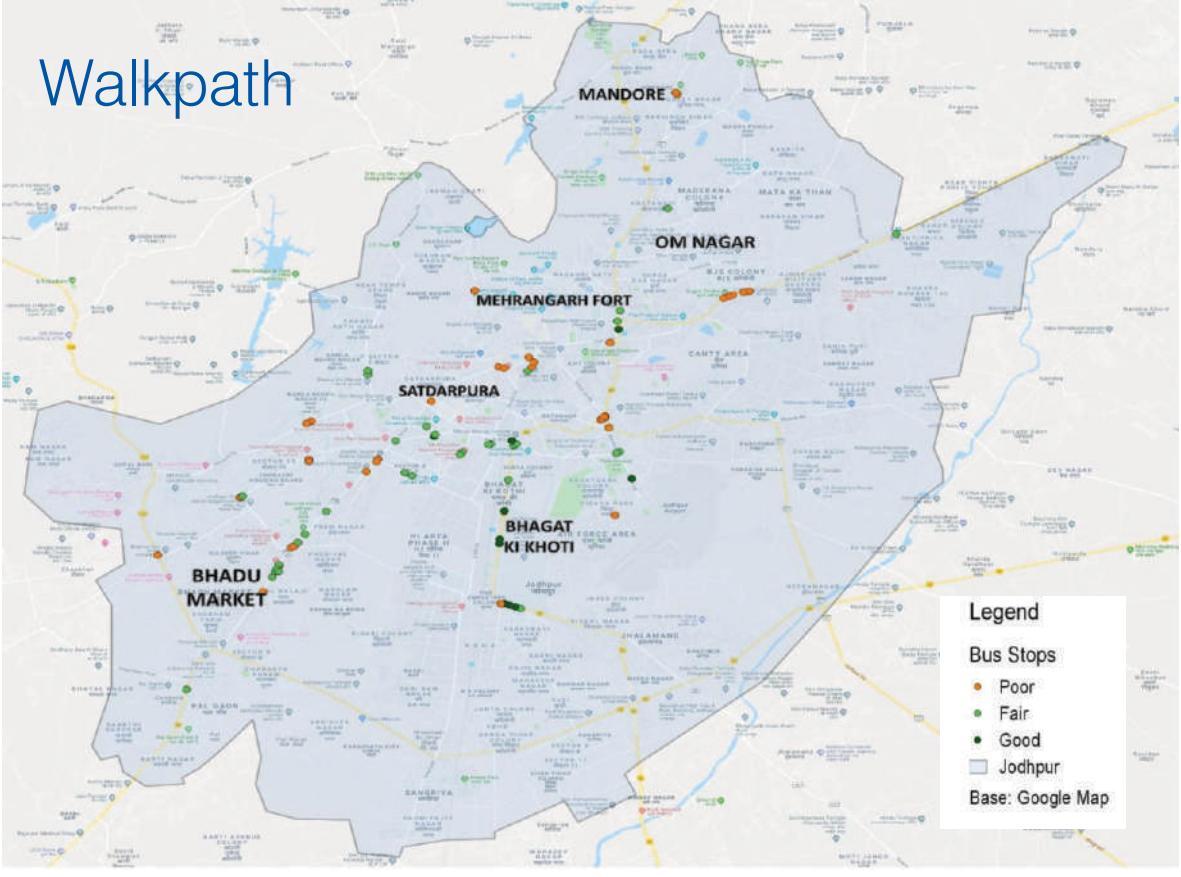
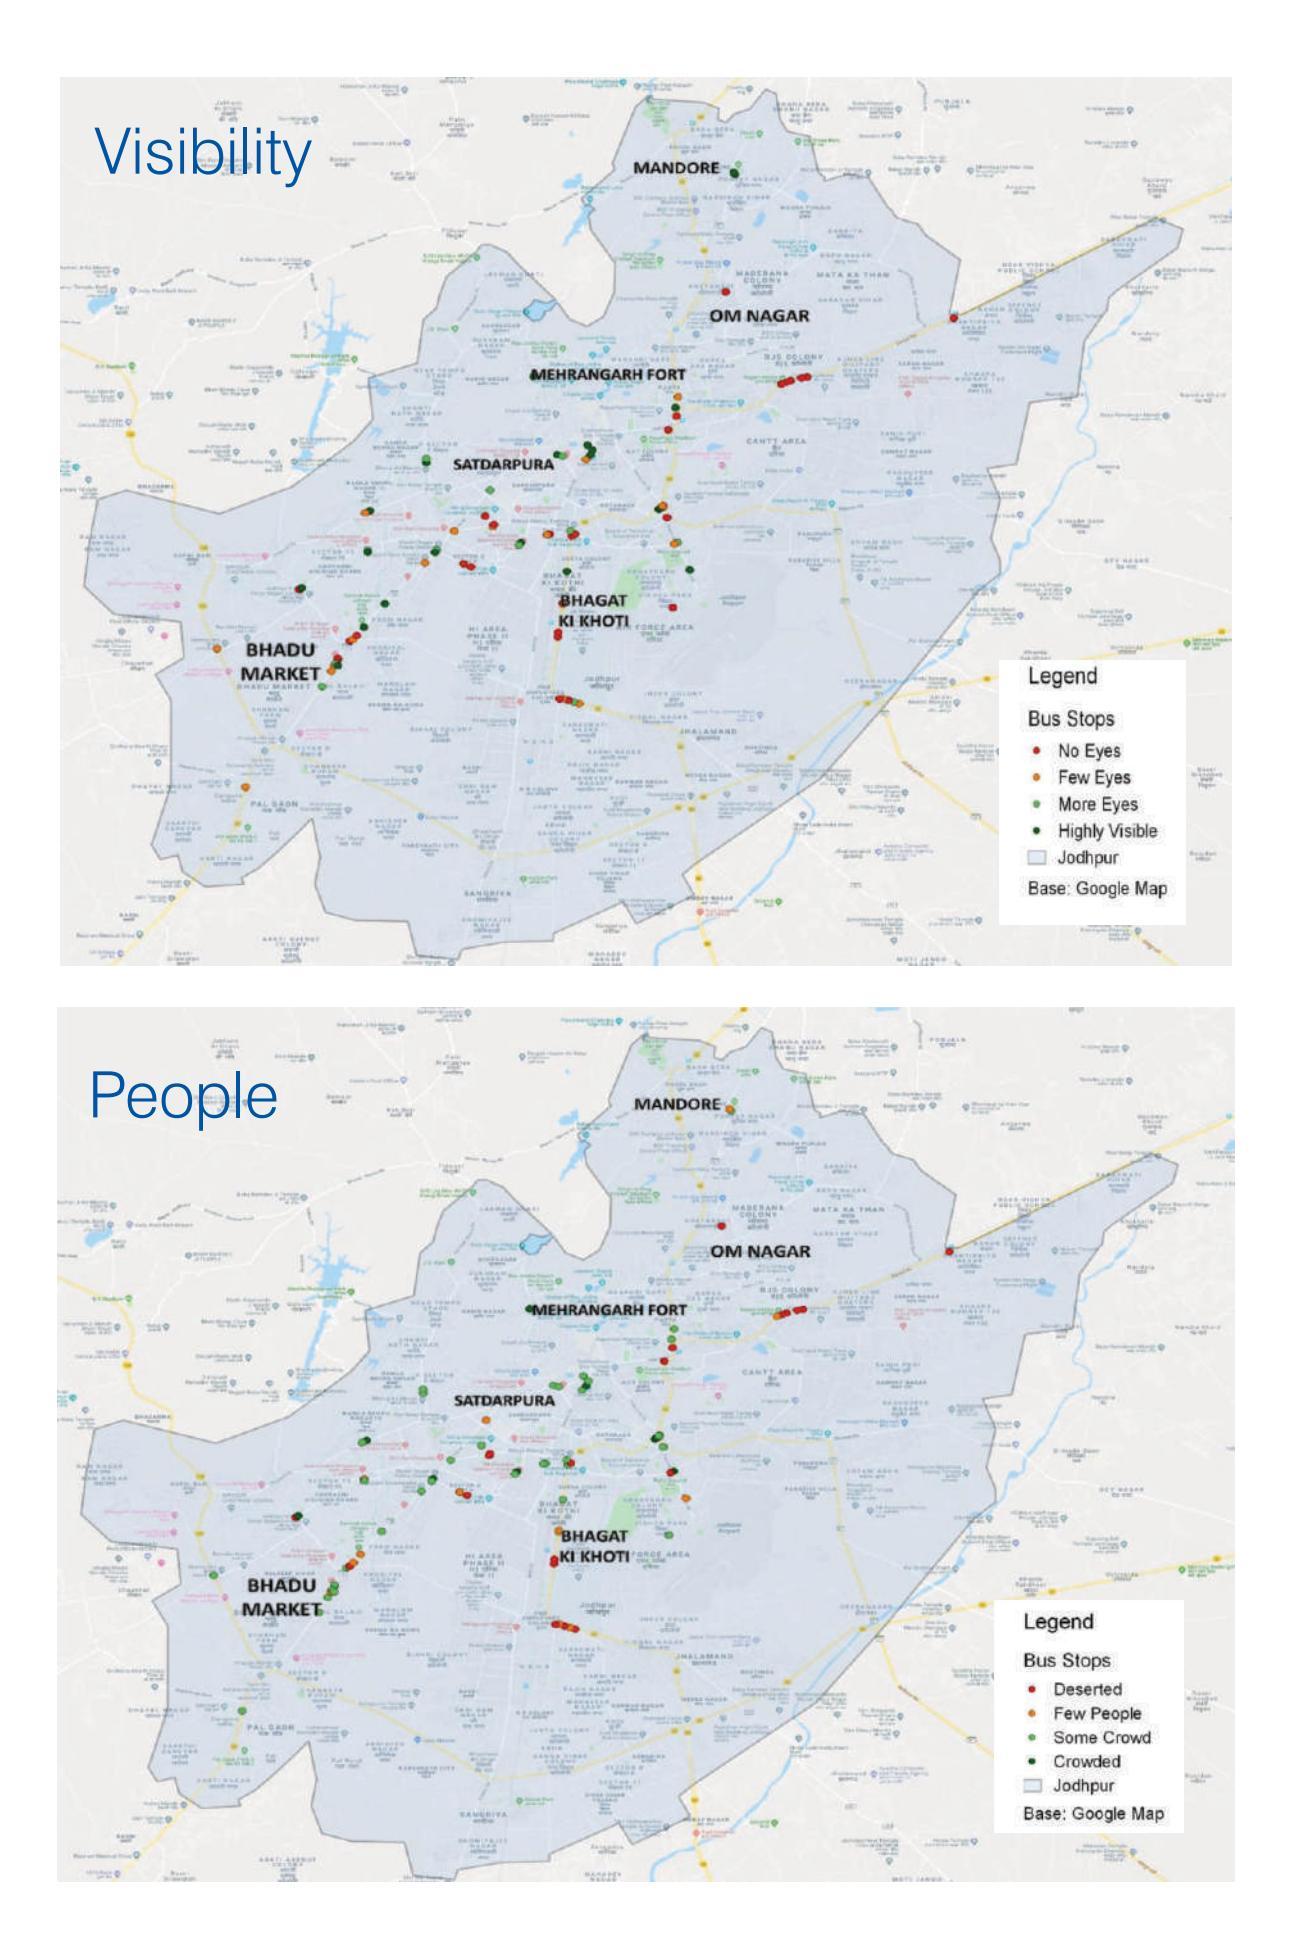
A total of 79 bus stops were audited using Safetipin app. The Safety Score map as shown below indicates that most of the bus stops have been rated Good in terms of overall safety. Individual maps showing parameter rating of Lighting, Walkpath, Visibility and People parameters are provided on the following pages.

Lighting was found to be adequate at most of the audited bus stops, however, the walkpath was found to be broken or unpaved at some of the bus stops. Bus stops need to be made accessible and convenient to use by providing obstruction free footpath.

Visibility has been rated poor and below average for many bus stops. In terms of co-relation analysis, Visibility and People parameter maps indicate that People parameter recorded low ratings at audit locations which were also rated poorly on the Visibility parameter. People tend to avoid bus stops that are deserted or have 'no eyes on the street'.
